Limited Visual Dam Safety Inspection Summary Report

MA-047

Piiholo 50 MG Reservoir

May 2006

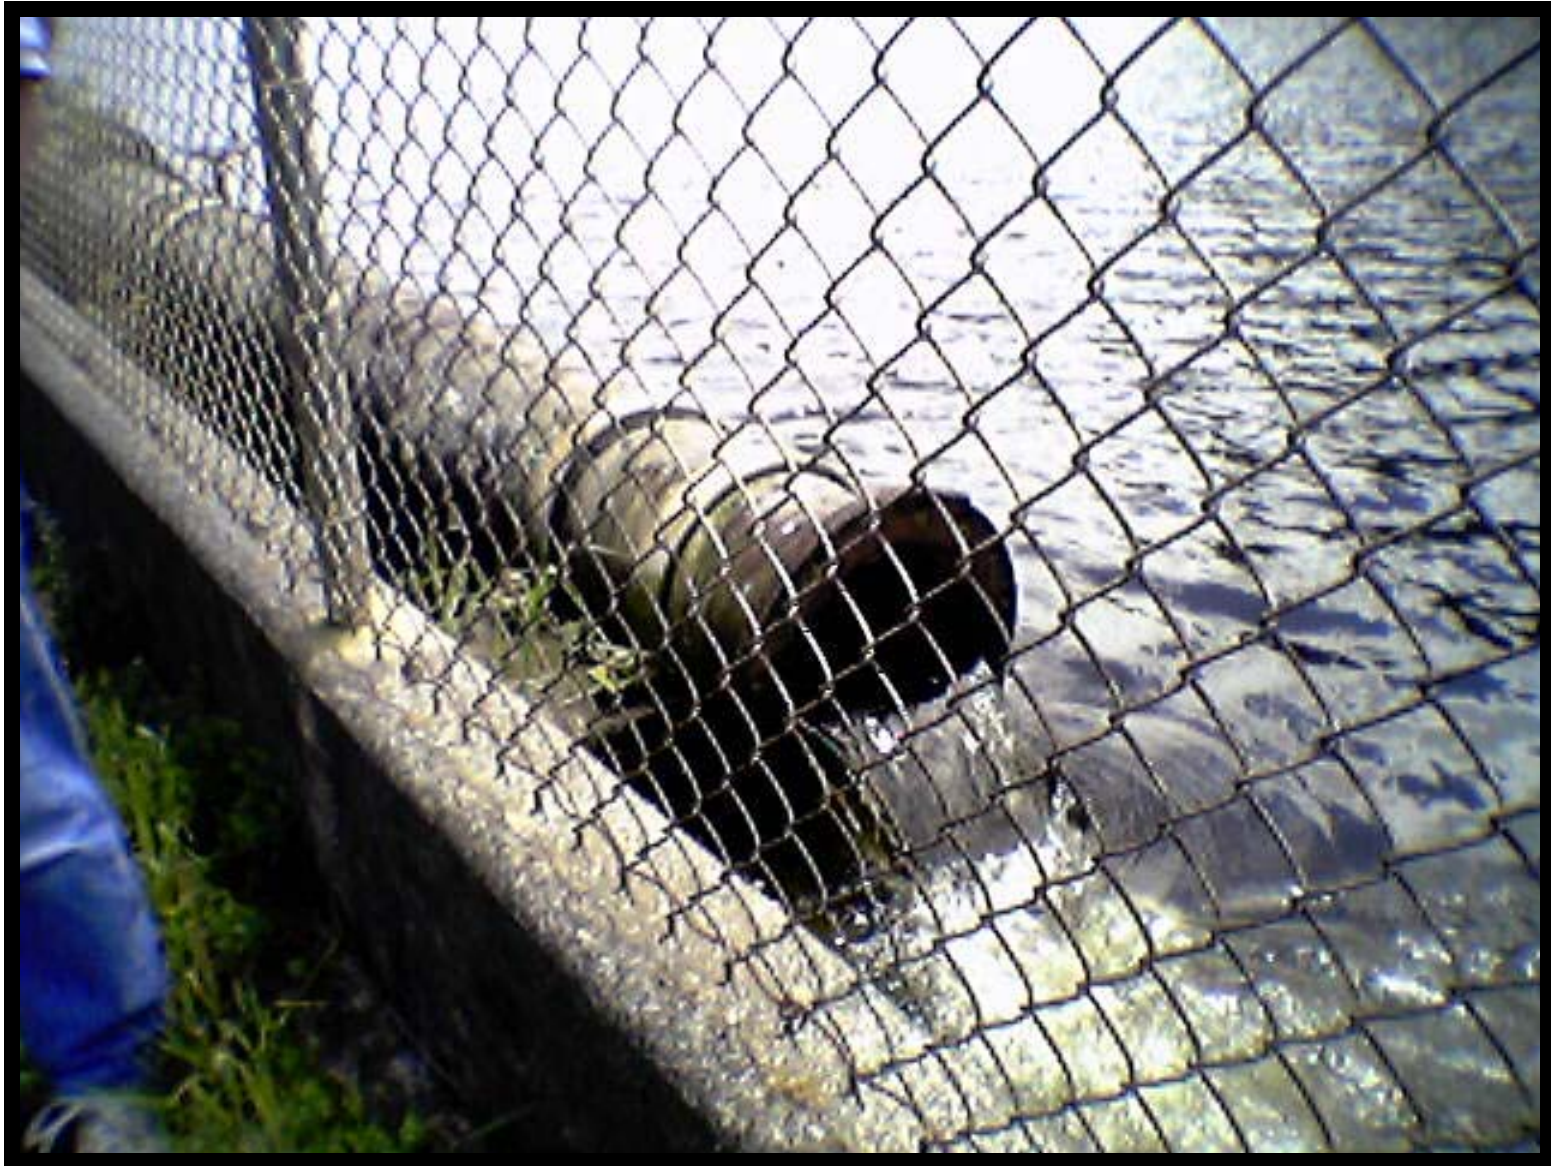
There were 2 outlet works pipes that are 12 inch in diameter running to the treatment plant. The pipes are DIP, and the valve is located on the downstream side.

- a. The outlet works were not inspected. (Submerged intake in reservoir.)
- b. The outlet works appeared to be in satisfactory condition, no corrective actions are required at this time.

047 View of dual 12-inch pipes at downstream end of reservoir.

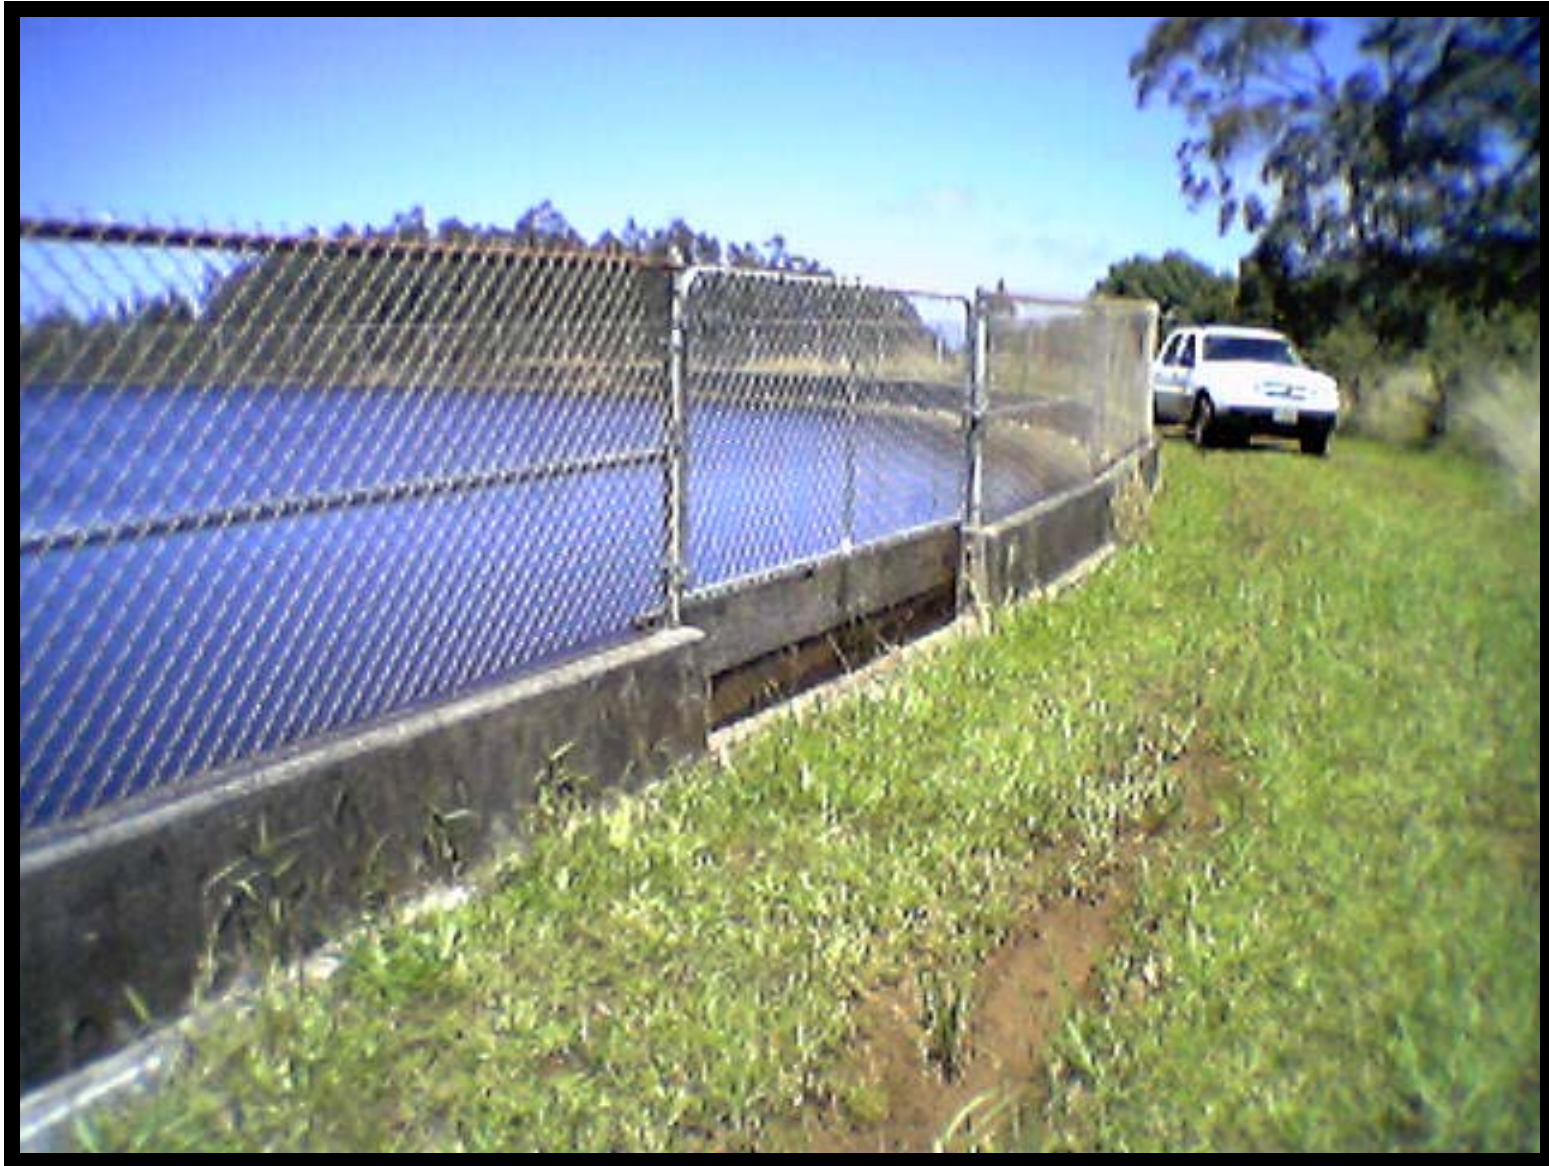
The dam crest was approximately 20 feet wide. There was a dirt access road on top of the crest.

- a. The dam crest appeared to be in satisfactory condition, no corrective actions are required at this time.
- b. Access along the crest was satisfactory.

047 Right Crest of Reservoir - View of mowed right crest.
